PRODUCT BULLETIN

Tyre rubber cracking and crazing

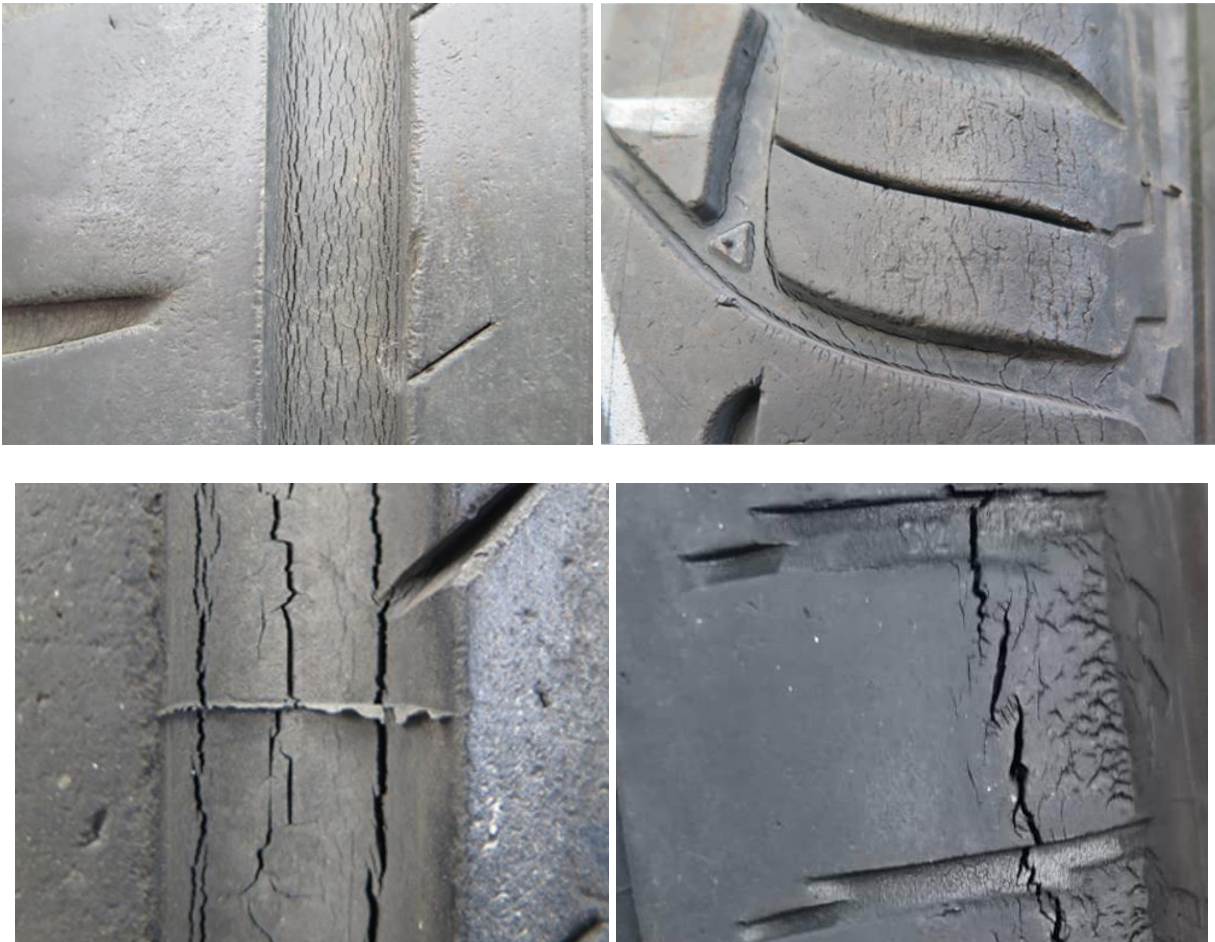
The surface cracks that occasionally appear have been called many things: Weather Crazing, Ozone Cracking, aging or Dry rot. These small cracks typically develop in the sidewalls, on the tread as well as at the base of the tread grooves. Depending on their severity, they may be cosmetic in nature if they don't extend past the rubber's outer surface or may be a reason to replace the tire if they reach deep into the rubber.

Example of weather crazing

- Non-service tyres must be stored in good condition, in premises that are well-ventilated, dry and temperate, protected from direct contact from the elements
- Avoid tyre contact with unusual heat / sunlight / chemical / ozone generating machinery / electric generators and motors (that have armature brushes)
- Avoid harsh driving
- Do not use harsh chemicals or cleaning products which can strip the tyre of its anti-ageing components
- Good maintenance of tyre inflation pressure
- Periodic usage of the tires (not parked for too long)
